G503 WWII Military Army Jeep Flywheel Ring gear replacement

This article shows the steps to replace your worn out flywheel ring gear on your WWII G503 Military Jeep (Willys MB or Ford GPW)

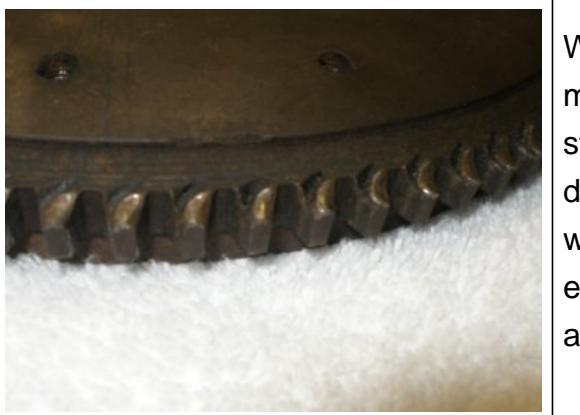
While into disecting your project, many times you come across a weak starting issue. In many cases, it is due to a flywheel ring gear being worn out. Here you see a perfect example where the flywheel ring gear are nearly completely worn out.
